# Ted's News

## May 2018

### Protect your Top Surfaces

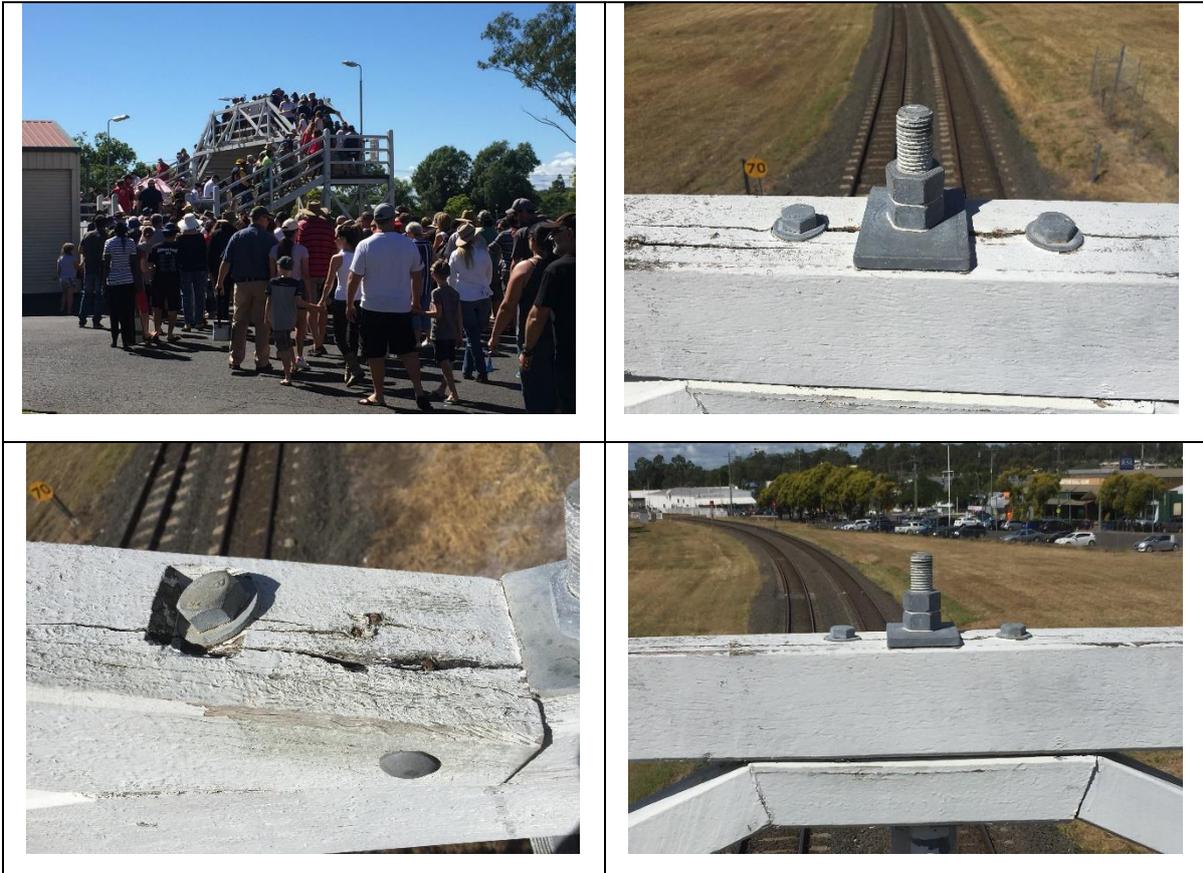
The annoying thing about footbridges, boardwalks and decks is that most of their life they are simply supporting their own weight and the usual design loads of 5 kPA and 4.5 kN can seem onerous. Then, maybe once in the structures life, it actually has to carry the intended load and, when it does, you need to make sure the details are right. The images are from the Gatton railway overpass bridge on Anzac Day and it simply couldn't take another person. So, **Lesson One** is to take the design loads seriously. But the **Lesson Two** is to protect the top surface.

I learnt early on that horizontal surfaces should shed moisture so all our handrails etc. did just that, hard to do with decking though. You can see from the top right-hand image that the bolt goes straight through a flat surface and there is potential for decay in the best of circumstances but in conjunction with the coach screws the top surface has split allowing moisture directly into the bolt

hole. On the bottom left hand image, the member was nailed into position before drilling for the bolt. The 4.5mm nail close to the end has split the timber, again allowing moisture to enter. The cross bolt intended to stop splitting does nothing as the timber shrinks. The last image shows a detail of construction. These bridges were built spanning 11.3 m if not more with these traditional joints. More on this in my books [Timber Joints and Commercial Barriers](#).

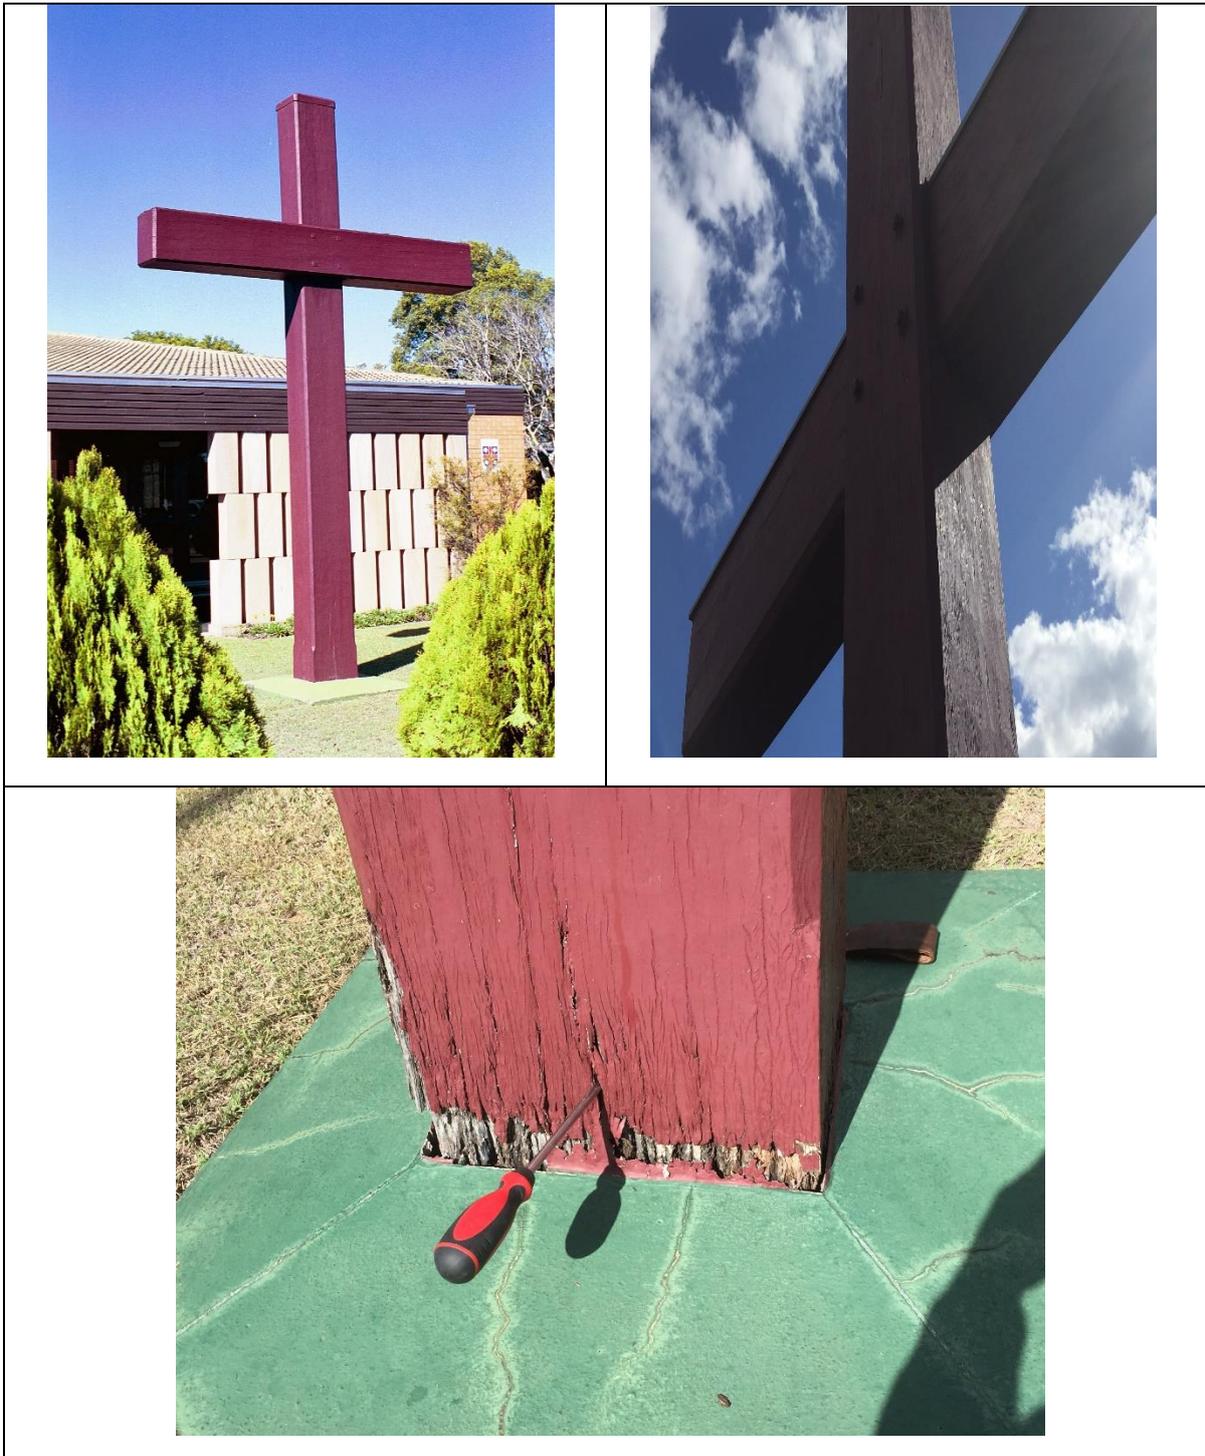
Now, this cross has been proving a liar out of me for many years for as you can see the shrinkage has been way under what would be expected which you can see from the gap in the concrete. Now, shrinkage was expected, and you may be able to see the joint of the arm to the post is tapered and was intended to be tightened as the timber shrunk. It never happened, and the joist is as tight today as when it was installed. Unfortunately, the Lockyer Valley is one of the worst areas in Queensland for ground line decay and this post has the further handicap of being set in concrete. The last time I inspected the base, which was about 5 years ago, there was still virtually no degradation at all. But at a wedding there on Saturday I saw that in the intervening period that the decay had been rapid. In the front there it was up to 100 mm deep and in the back up to 50 mm i.e. half way through.

If we can learn anything from this cross, it is that your design sins will eventually have a consequence. You can read more about this design issue in my book [\*The Seven Deadly Sins Of Timber Design.\*](#)

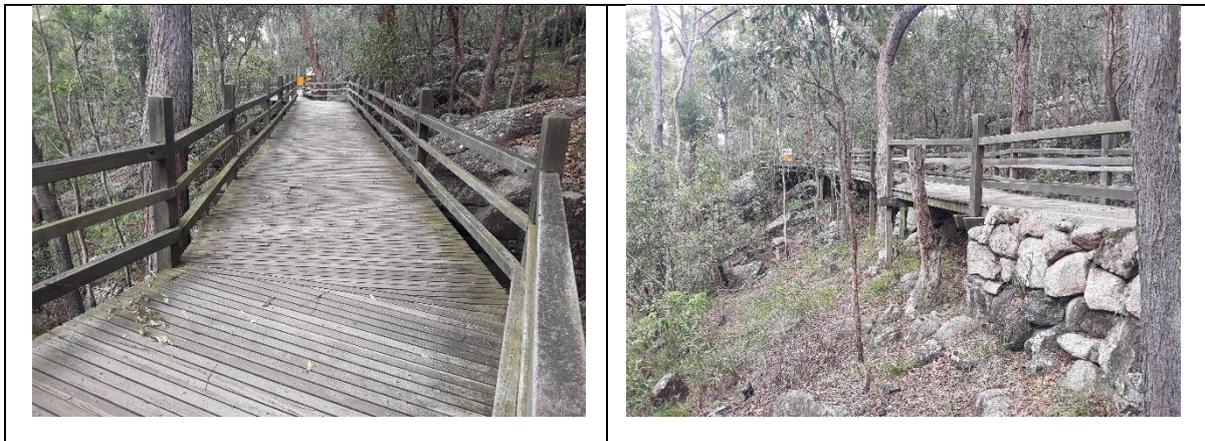
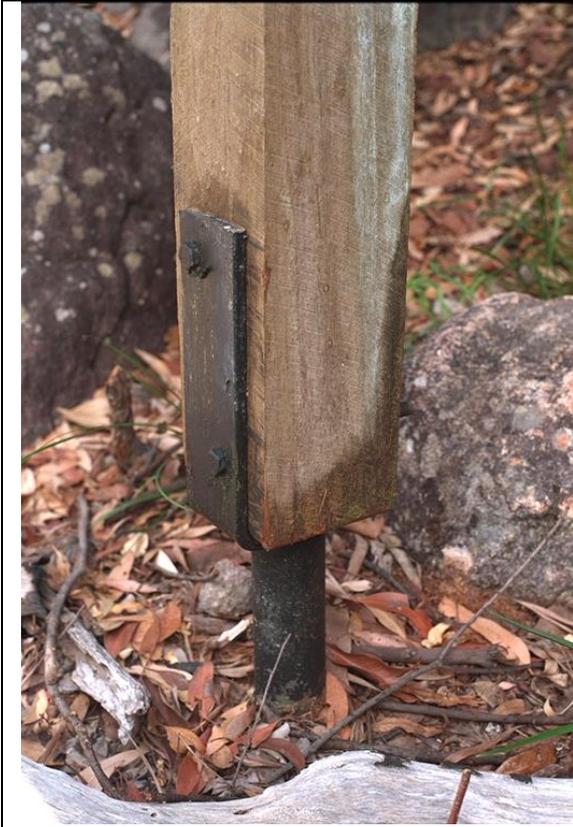
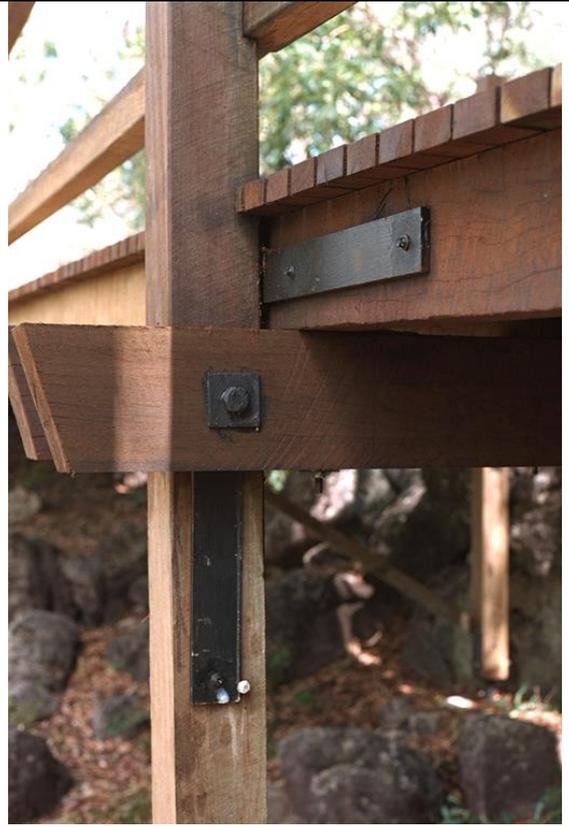
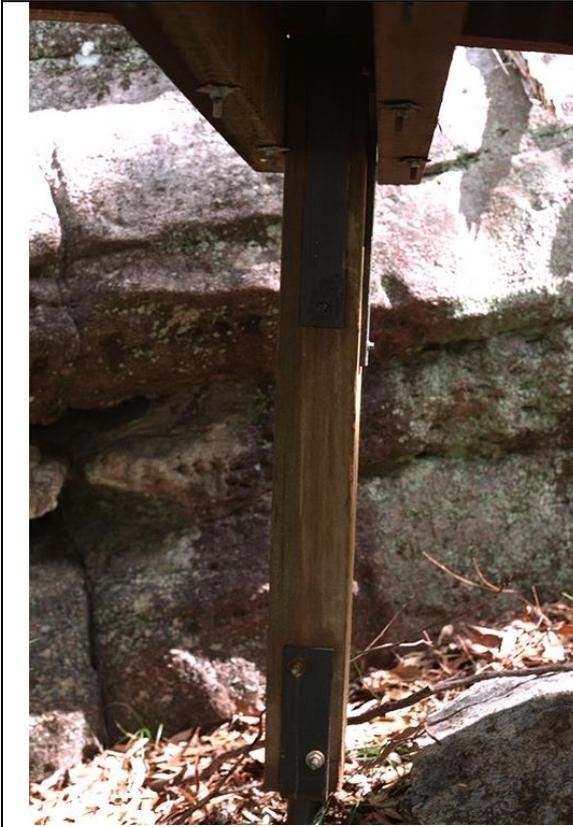
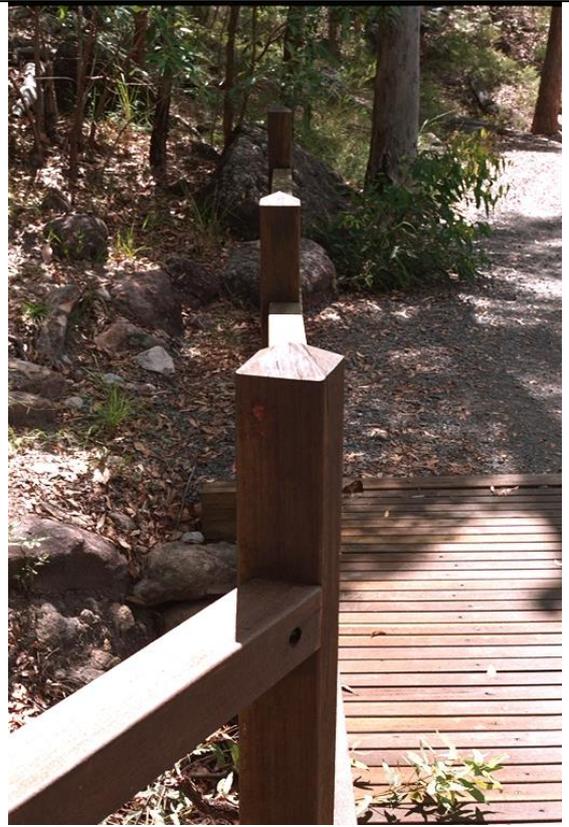
**Project:** Toohey Forest Park Boardwalk

I was doing preliminary design work for a small boardwalk at Toohey Forest Park in Brisbane and I asked my contact in the Council how an old boardwalk I supplied the design and timber for was standing up. He commented that it was in excellent condition further adding "It certainly still feels like it fits and suits the landscape that it was built in those many years ago."

The top two images show the boardwalk now after 21 years. What was special about this boardwalk was that it was built on rock meaning we couldn't put our normal H5 pine posts in the ground. The left-hand image in the middle row shows a custom made post support painted with a tar epoxy paint to help with corrosion. In 2018 it would be stainless. Of course, that support will not give the rigidity required so that was achieved by incorporating large L brackets where the post met the bearers. All the galvanised items were also coated with tar epoxy.

The posts were sawn 125x125, note the pyramid tops to shed moisture which is not easy to do neatly on sawn posts. Fire was considered a risk in his location and all the timbers were fire resistant and a fire retardant was applied at the time.. We came to the conclusion that for large changes of direction that round posts were better suited than sawn.
