Ted's News

July 2018

[Another Great Timber Structure at Toohey Forest Park](#)

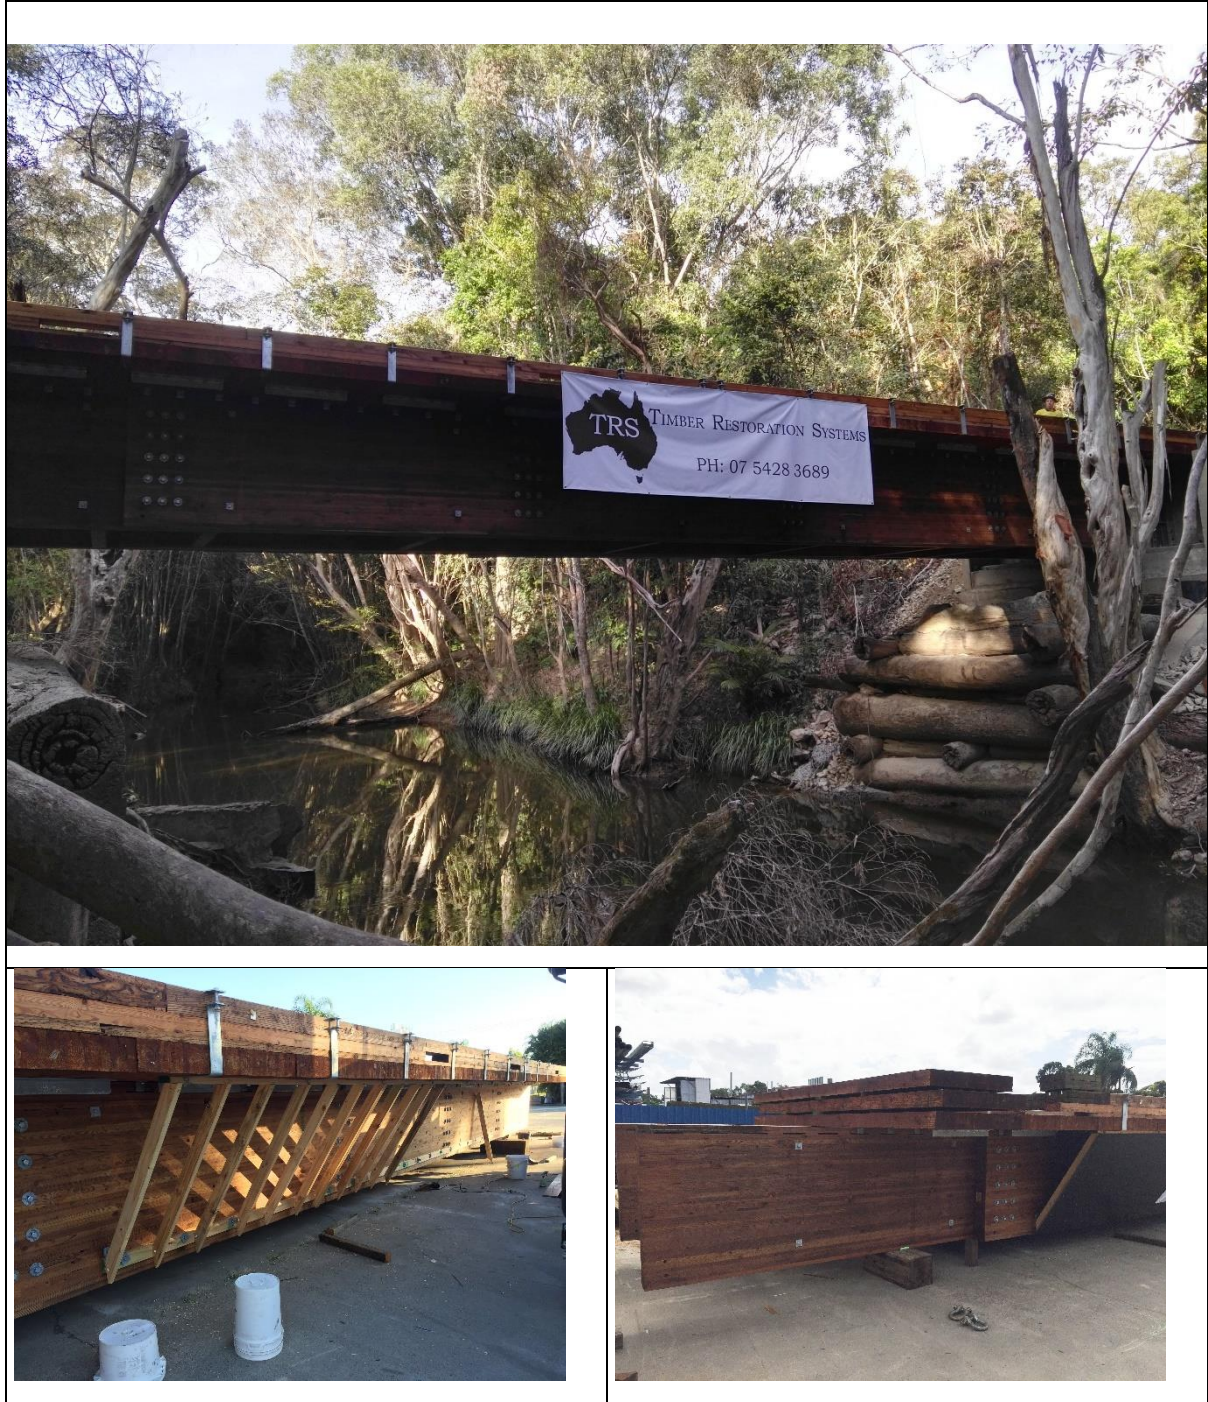
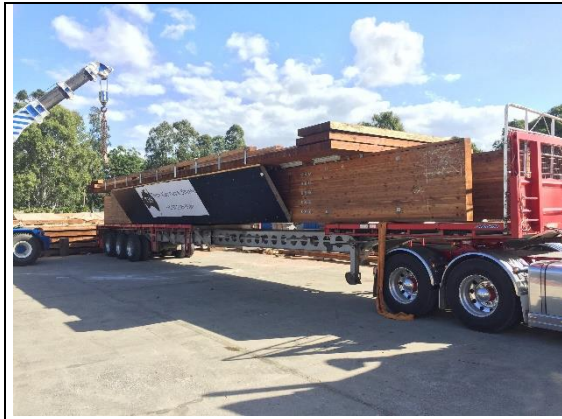
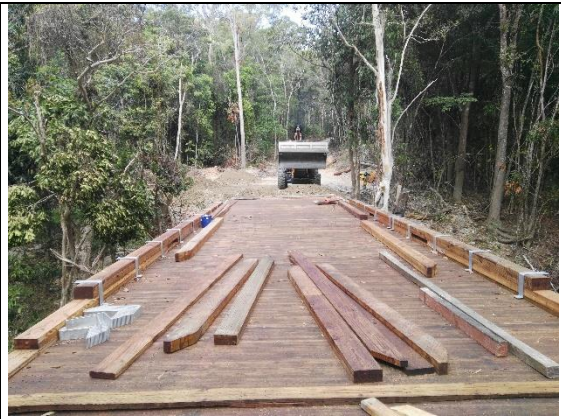
A Level 3 bridge inspection of the 18 metre Flaggy Creek bridge (2x9 metre spans) conducted in 2017 for the Mareeba Shire Council indicated severe problems with the superstructure and timber abutments. Consequently the bridge had its load capacity reduced to 3 tonnes. A low cost, but still durable clear span solution was sought from Timber Restoration Solutions (TRS) for a replacement with a 25 tonne load limit. The Mareeba Council reported that the bridge was installed on time and on budget. In fact, a new bridge was installed within a month from the placing the order.

The bridge is actually a stretch bridge which can be supplied from between a 14 to 24 metre span and is constructed using stock material held at TRS's Caboolture yard. The bridge is built on four 171x1257x14600 mm incised Douglas Fir glulam girders stitched in pairs using [4" dia shear plates](#) to make two 18m long girders. The treated beams are fabricated with cyclic delamination resistant glues which ensure a very long service life. The capacity at 18 metres was the required 25 tonne. Dr Dan Tingley of TRS described this bridge as a "Low cost, quick and effective solution. It is a fraction of the cost of concrete or steel."

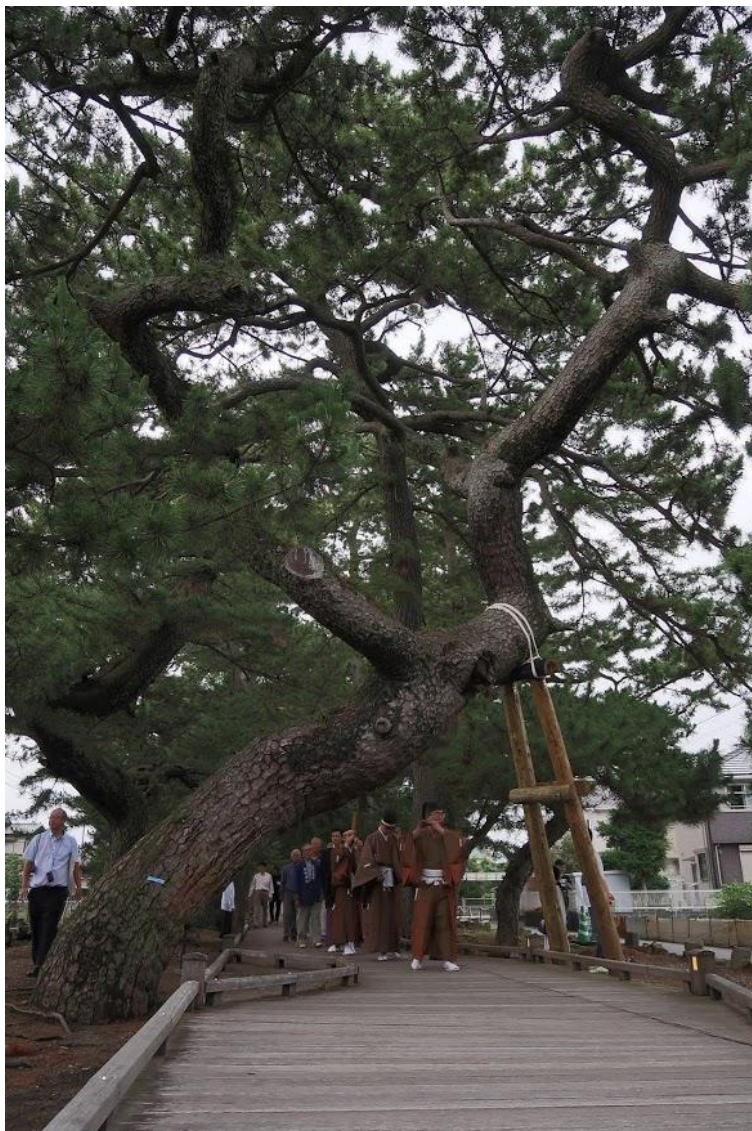
Boardwalks do not have to be installed in the ground. The image below shows a spotted gum boardwalk during the summer festival at Miho in Japan. It sits on simple bases, so that the roots of the pine trees of this sacred grove, through which this 450 m long boardwalk runs, are not disturbed. Image courtesy of Aki Kurata of [Kurata Co.](#)
