Ted's News January 2020

A Lesson from the Recent Bushfires

Pre-War but Which War

An OSA Boardwalk Used as a Teaching Aid

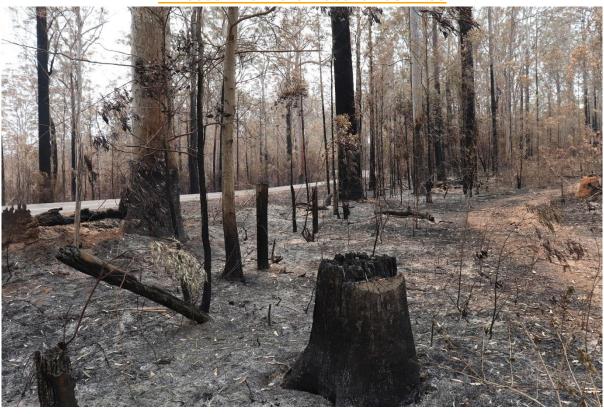
The picture above shows damage to fencing on property our family sawmill once owned at Ravensbourne near Toowoomba. Over 30 years ago we fenced along the highway using split posts and barbed wire with natural rounds as strainers. Because we could, I treated the posts which all had had sapwood with CCA. Soon after installing a fire went through a portion of the fence line and the destruction in the posts was far worse than anything you would have expected. I asked my chemical supplier about this and was informed about "afterglow" in CCA treated timber. Basically, after the fire passed through, the chemicals in the CCA treatment caused the timber to

continue to burn. That wasn't in any of their literature that was provided to their treaters. A few weeks ago, another fire went through and the remainder of the fence was lost. The round posts with treated sapwood all around were burnt completely. Pity, as the posts were in excellent condition despite being over 30 years old.

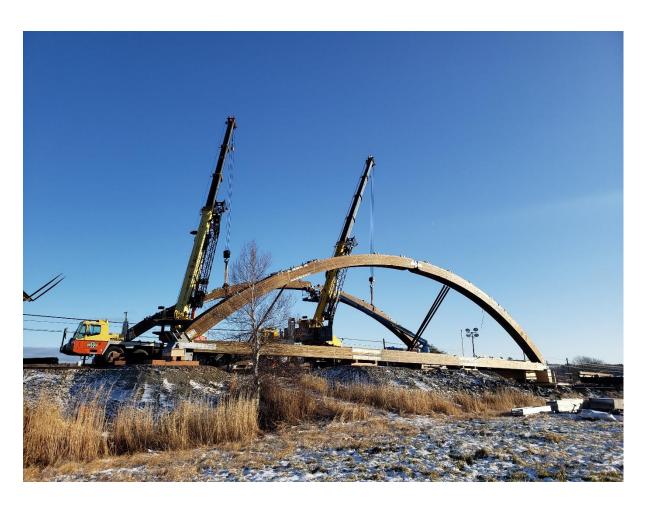
WRD and Timber Restoration Services (TRS) were commissioned to design and construct the Nappan Marsh Bridge, also commonly known as the Rainbow Bridge, that traverses the Nappan River in Nova Scotia, Canada. The prior structure which comprised a steel arch and timber pile substructure was decommissioned and dismantled in early 2019 due to structural integrity issues following 47 years of service. The bridge is located in the highest embedded and exposed corrosion zone in the country where steel simply doesn't have the longevity to match a timber structure. The old steel structure was built on timber piles which supported an old timber bridge the steel one replaced. Additional timber piles were added to the substructure when the steel bridge was built. The new bridge design incorporates the existing substructure timber piles (A COMBINATION OF 78 AND 47 YEARS OLD) and accommodates the vertical alignment and soffit height stipulated by Nova Scotia Transportation and Infrastructure Renewal (NSTIR). The 3-lane glulam bridge design includes two 12.5m girder under approach spans and a 40m 3 pinned arch middle span, Canada's longest clear span three lane design timber bridge. The existing

timber pile substructure, originally set to be removed, were incorporated into the CL-625 ONT load case design to support a 100-year design life glulam substructure, superstructure, kerb and guardrail system. The old timber piles will now stay in service for another 100 years beyond the 78 years the majority have already been in service for. Site preparation works commenced in June of 2019 in parallel with prefabrication works of the glulam elements. Substructure installation works commenced in mid-October and in December of 2019 the centre span was lifted into place. The bridge was open to traffic on 20 December 2019.

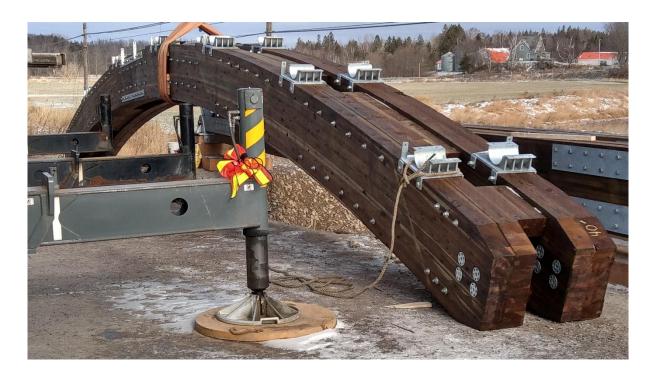
WRD's Australia division were heavily involved in the design and drafting of the Nappan Marsh Bridge replacement project. Once the design was approved and materials ordered, technicians from TRS (Australia) travelled to Oregon, USA where initial manufacturing took place and then on to Amherst, Nova Scotia to assist with the pre-assembly of the structure in a nearby warehouse and then on site to be ready to complete the final install. The Australian team assisted with staffing both shifts of the 24 hour round the clock program to ensure timely prefabrication of these major elements and to gain the experience of handling such large bridge components.

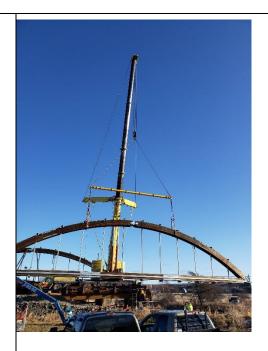
Collectively, Australian staff contributed to the bridge design, drafting, project management and construction phases of the project. TRS was praised by its client, Nova Scotia Transport and Infrastructure Renewal for including its engineers and in the construction teams to gain valuable experiences which will benefit their future careers.
