Ted's News

June 2016

[Galvanised Bolts More Variable Than Timber](#)

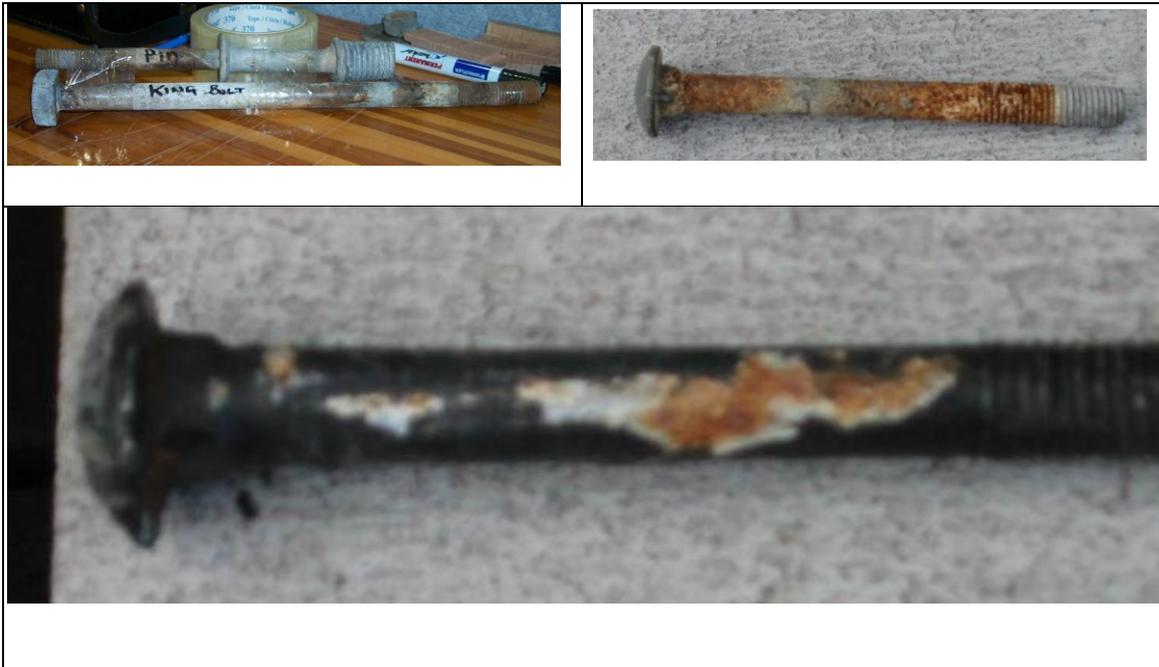
The image on the top left hand is of an Australian made bolt installed on a cross arm on a powerpole at Millmerran in 1950 and removed in 2001 and which, after 50 years, still has some galvanising in place, The image on the top right is of an imported bolt after 12 months in Gatton, a very similar environment. The galvanising has completely failed,

The lower image is of a bolt painted with a suitable epoxy and removed after three months. The galvanising has separated from the steel taking the paint with it. When I saw this bolt I took some of the same batch to a laboratory to tell me what was happening. They looked at the bolt and said, "Look how shiny it is. It must be electroplated, but we will check it to be sure." They rang back to say that they were indeed hot dipped galvanised and according to the relevant standard were very well galvanised. They further commented that obviously it was not working and could not offer a suggestion why. Because of this I have always, in my CPD sessions, advised professionals to specify stainless bolts because it left us as a supplier with a real quandary as I would never sell anything if I priced with the more expensive fastener.

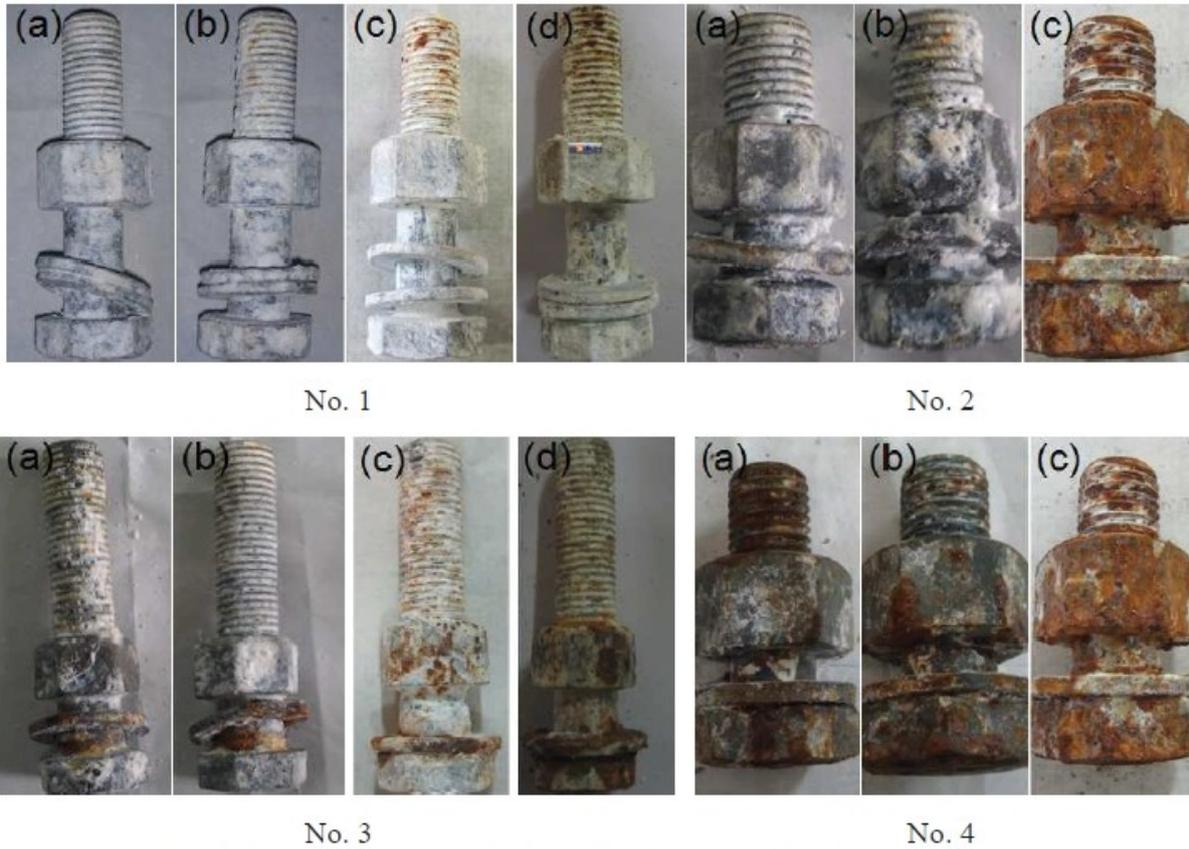
Fig. 1 Corrosion photos of No. 1 ~ No. 4 in neutral salt fog environment
 (a) 500 h; (b) 1000 h; (c) 1500 h; (d) 3000 h

Until now, I have not been able to get publically available information on how bad the imported bolts can be. It was as if there was a conspiracy of silence. An article written in the Journal of Applied Mechanics and Materials on the anti-corrosion performance of four randomly purchased bolts in China identified the problem and more importantly offered suggestions as to why. The conclusion was □□□□ *"The anti-corrosion performance of the four hot-dip galvanizing bolts obtained from different company were all unsatisfactory. The causes of the above phenomenon are the lower thickness of the hot-dip coating, too much defecys on the surface of the coatings and the elemental composition impurity"*.

How great was the variability of the galvanising? the average coating thickness on individual bolts went from 130 um to 34 um and the minimum was 13 um which happened to be on the same bolt that averaged 130 um. This is greater variability than timber and can mean that the bolt, not the timber, is the weak link in the system.

Note: The journal article is Li. Cuoxin, Shanjing Xia, Yilang Peng. Anti-Corrosion Performance of Four Hot Dip Galvanising Bolts in *Applied Mechanics and Materials Vols. 395-396* (2013) pp 708-711
