Ted's News November 2018

Inspecting the Timber in a Venetian Palace

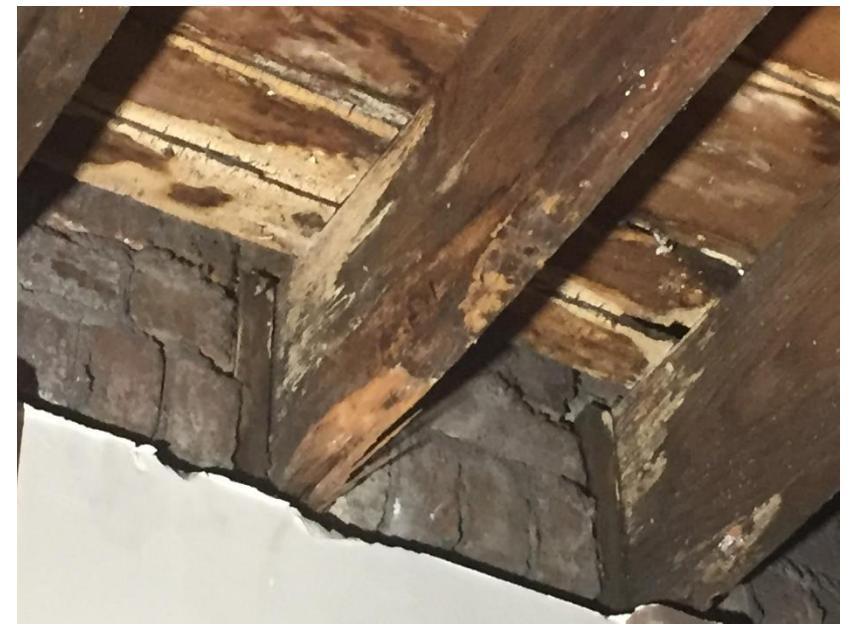
Ok, it might not actually be in a palace in Venice, but it is as close as you will get to one in Australia. In the latter part of the 19th century in Melbourne, business owners wanted to display their great commercial power and prestige, so they built their office buildings in the style of Venetian palaces. One of these is now being restored. As a Senior

Timber Consultant to <u>BCRC</u>, the durability experts, I graded the timber floor joists for the developer and, in this, I was admirably assisted by Shane Connolly, the then BCRC Victorian Manager.

The significance of the age of the building is that it was built in a time when stress grading of timber was unknown. Modern fasteners and connectors were either just starting to become available, as in the case of wire nails, or simply unknown. The timber is mainly Douglas Fir so the logistics of getting if from the USA back then must have been a nightmare. The lead picture shows the floor joists to the upper floor and the effect of a leaking roof. Incredibly, the upper floors had 6.0 m ceilings! As expected from old timber, the quality was brilliant. Top marks for a remarkable project.

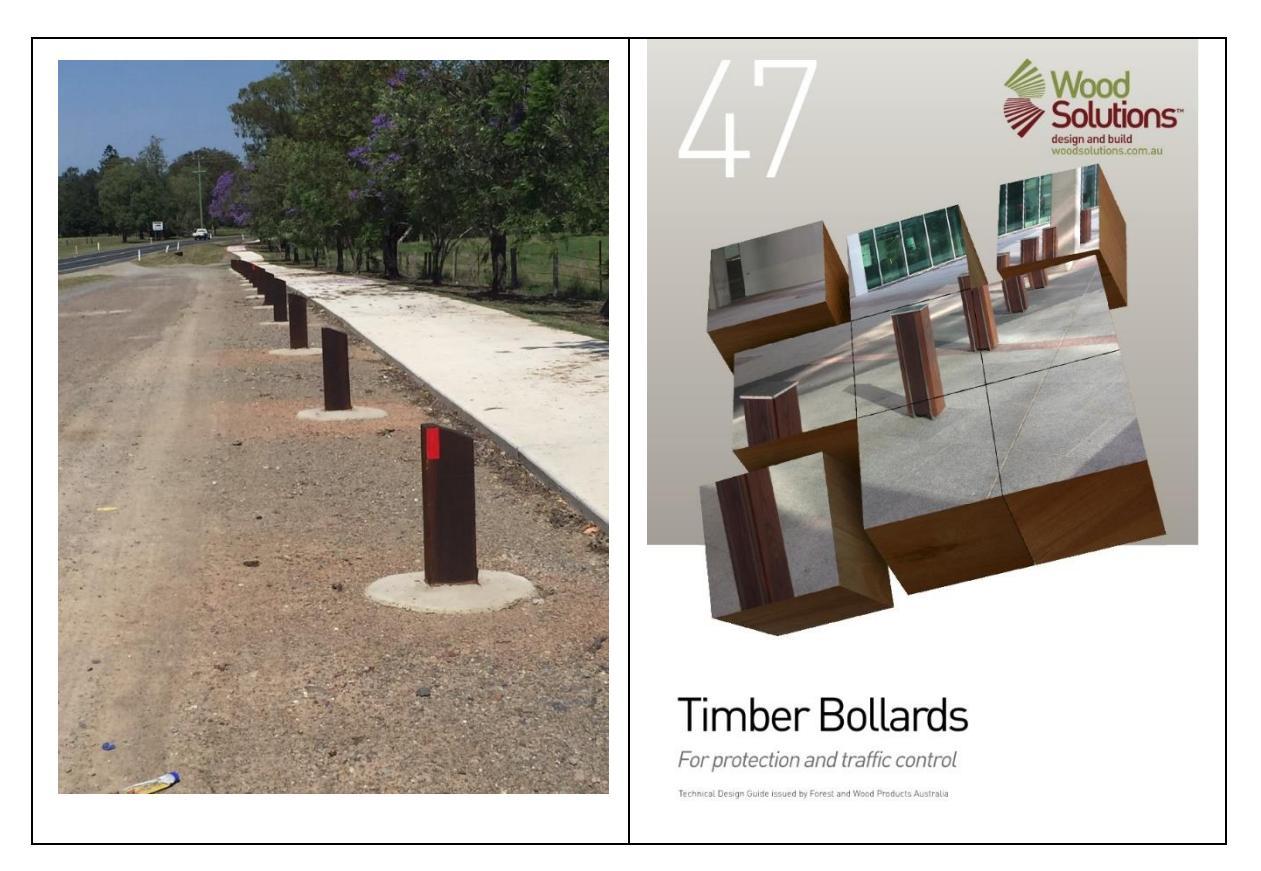
I have attempted to wax lyrical about the rapid advances in timber technology in recent years but there are times when I despair for the future of timber when we can't even get the basics right. The only consolation is that I am told it is the same with every material!! Take these bollards I saw on a recent drive where every one is set in concrete. Knowing not to do this is not secret men's business - the information has been out there for a long time. This is such a common bad practice that I have included it in my book and CPD course <u>The Seven Deadly Sins Of External Timber</u> <u>Design</u>. Further, at a recent CPD session one Landscape Architect told me that while some batches had no issues, they were in other cases making the contractor replace up to 30% of the timber bollards prior to handover. This would be because of included heart.

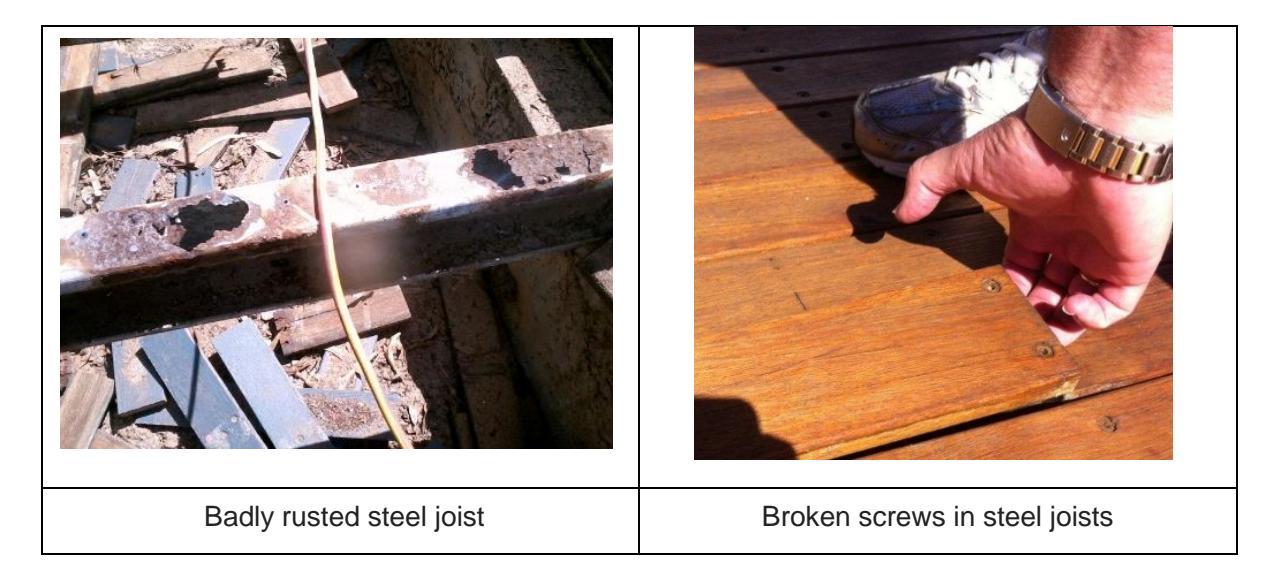
Recently, I was asked to comment on a deck which a previous report had slammed as being substandard because the screws were countersunk too deep. It completely missed the point that it was fastened to lightly galvanised (125 grammes per m²) steel joists right up against a swimming pool. The screws, while an issue, were the least of the problems.

When you go from timber to steel you swap well known problems that are easy to design around with a totally different but also less known and harder set of problems. A "C" section has less torsional stiffness than timber, the lip holds water, flexing of the timber and the joists snap the screws. Further the galvanising is too light to deal with the acidic species that may be used let alone the new treatments which are also more of a corrosion issue than CCA. If you read the technical data you see that the joist manufacturers say do not screw timber to the joists but use hardened steel nails. <u>See here for more info on this subject</u>

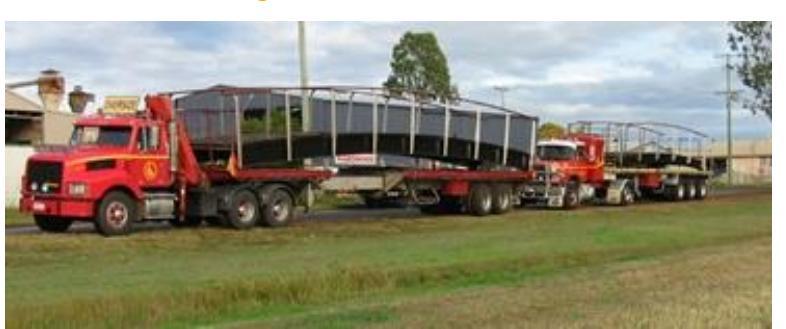
The image is of two magnificent footbridges leaving the old OSA site. I have been asked to prepare a full day seminar on footbridges and that is now complete. The
