December 2015 Newsletter

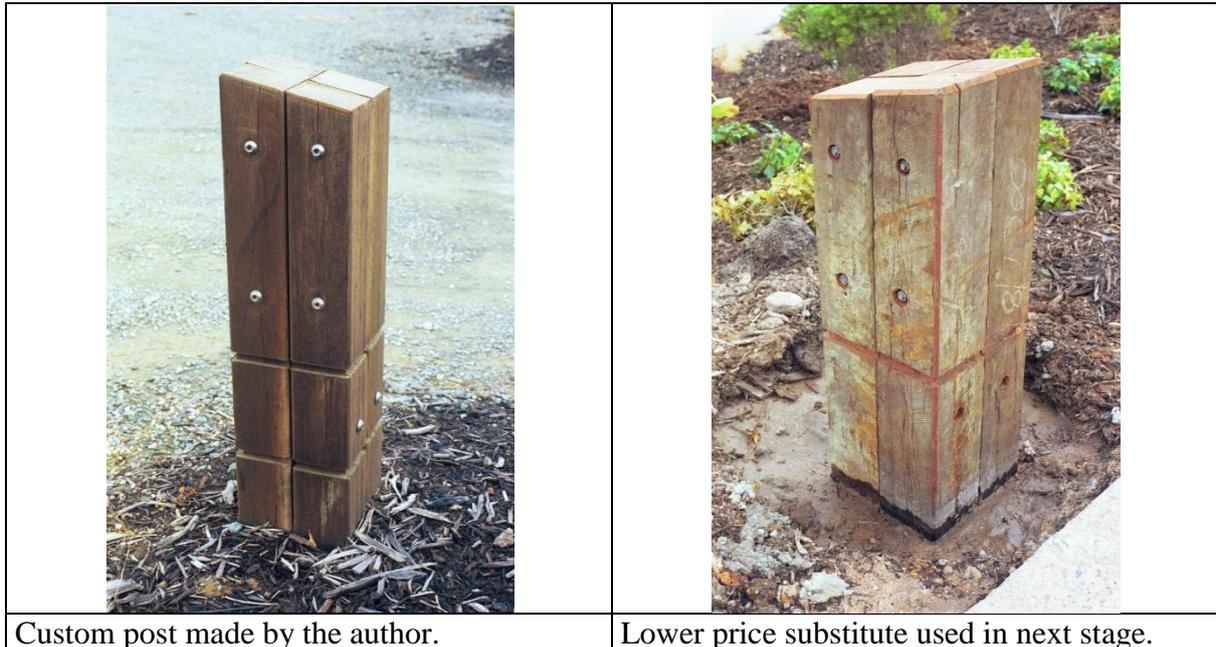
Our consulting engineer once told me "There is a lot less information in the plans that I prepare for you compared to the ones I give others". He explained how over the years he understood our fabrication processes so it would have all been superfluous. When you do not have this control and confidence, which you can't have when landscaping goes to public tender, you have to detail your plans so there is no "wriggle room". If the designer has a high expectation he/she should provide more than basic dimensions but provide fabrication details as needed to achieve the finish envisaged. A well detailed commercial product does not happen by accident with the lowest price tenderer! The two figures above illustrate how two very different aesthetics and qualities can be achieved from the one set of plans.

To assist you in assessing the extra information needed consider the differences between these custom bollards are:

- Sleeve nuts versus countersunk nuts
- Timber processed then treated versus treated then processed
- Tanalith E/ACQ versus CCA

- Grooved, assembled and then the tops cut versus all theoretical measurements
- One set in no fines concrete (not visible from image) and the other not, and
- Dimensions sanded off versus dimensions left on timber

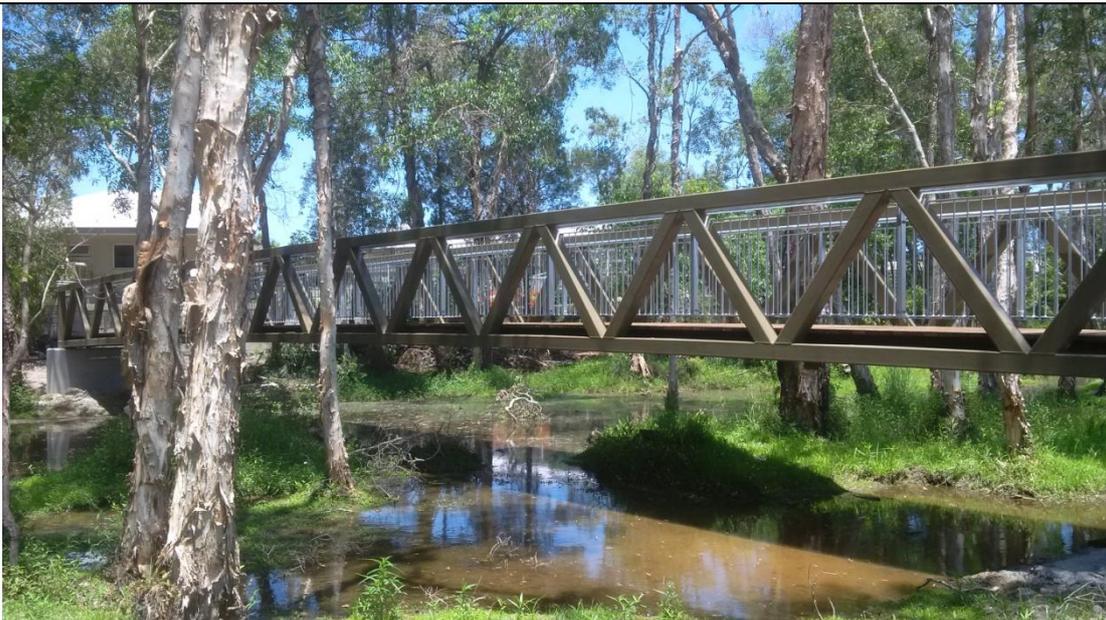
25m truss at retirement village - Gold Coast - Installed Dec 2015

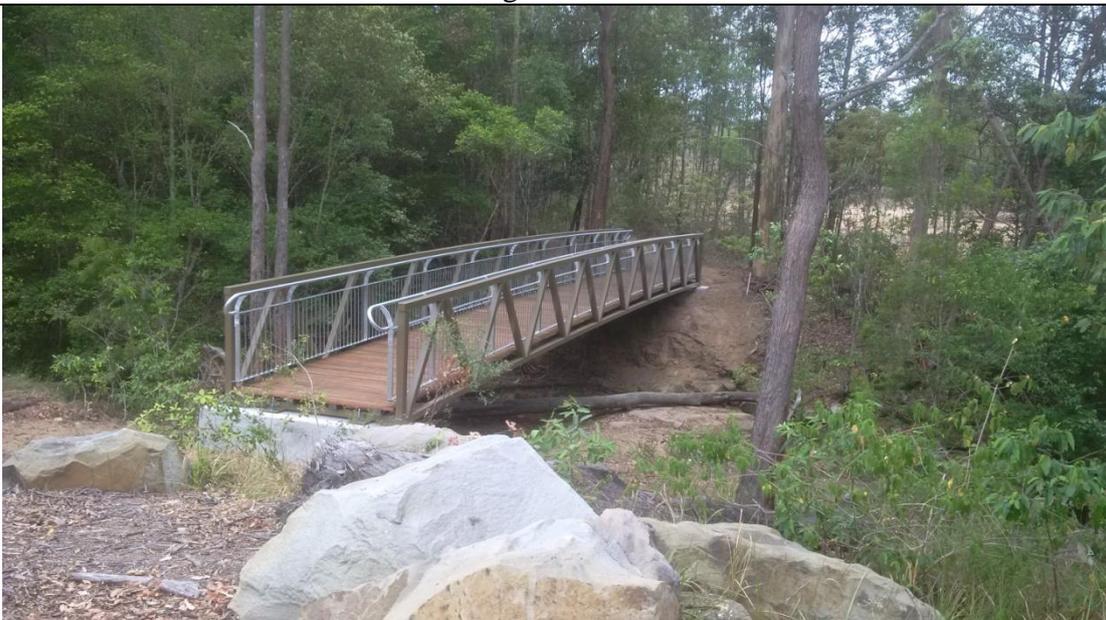
18 m truss bikeway installed at Landsborough in Dec 2015

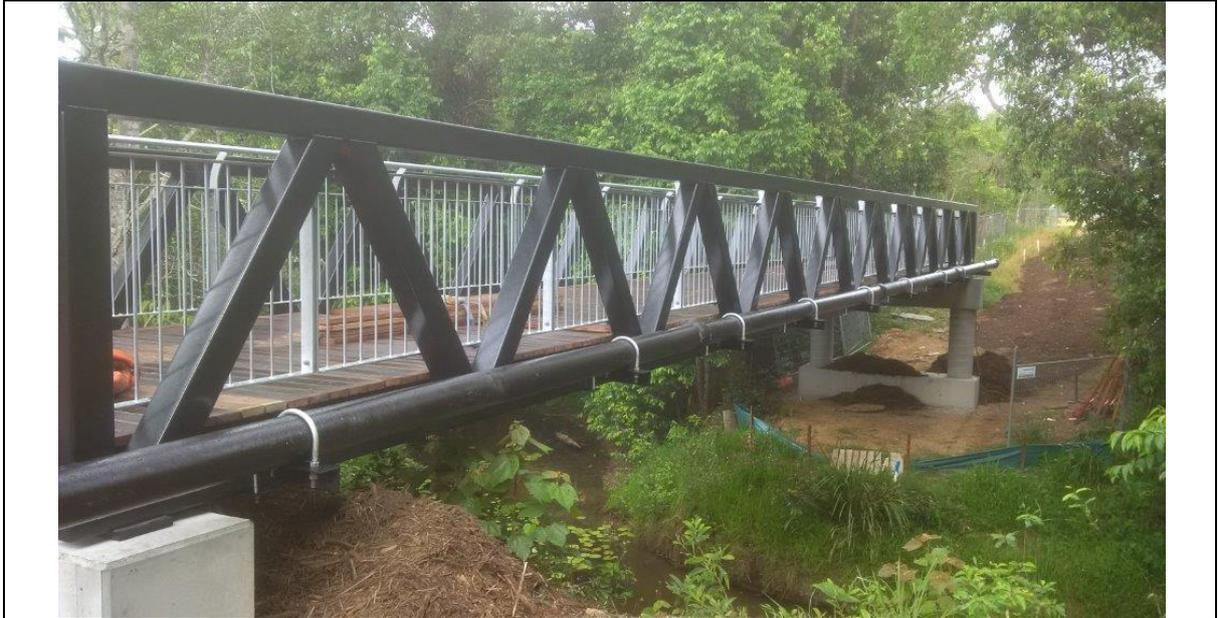
20 m truss installed at Cooroy Dec 2015 - an OSA boardwalk will attach to both ends

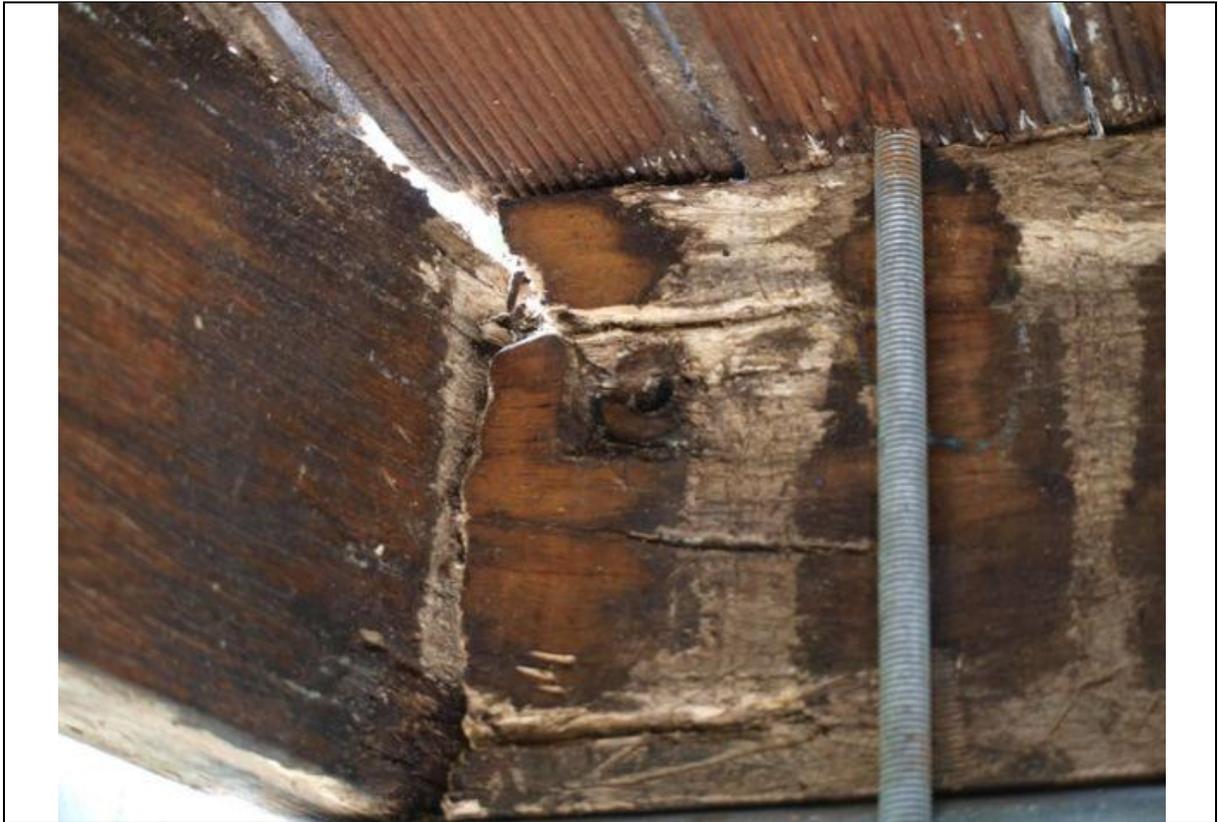
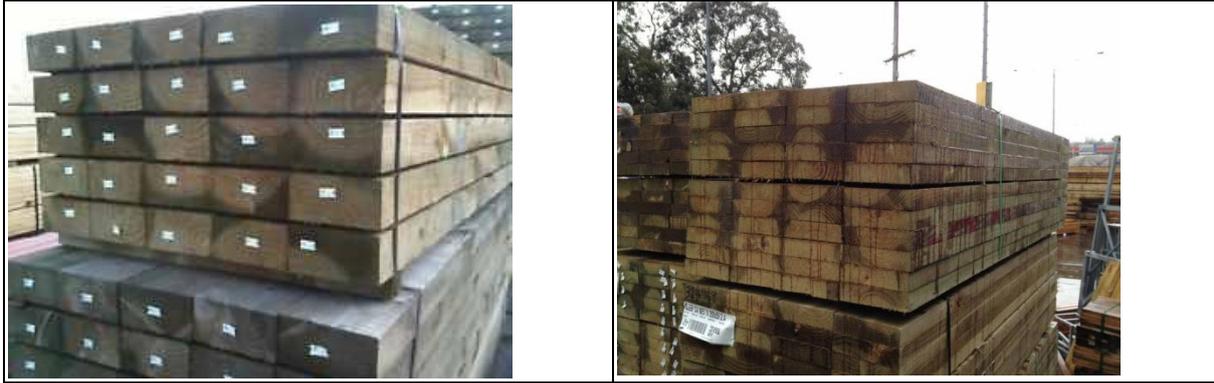
Treating pine is no guarantee of success, just as it isn't with hardwood. Consider the two packs of sleepers above. You can easily see that only a small part of the timber is actually treated. The heart of pine is just as untreatable as the heart of hardwood. The outside of the two packs is coloured green but not the bulk of the inside. It is still durability class 4 material being used where you need a class 1 and simply has to fail. The maximum amount of untreated heartwood should not exceed 20% but in these cases above it is probably 80%. This is why treated pine can decay.

If I was purchasing significant amounts of pine I would require the timber to be incised to a depth of 10 mm and treated to H4. The incising process allows the chemicals to penetrate the heartwood and the extra chemical cost is not significant.
