Ted's News

June 2020

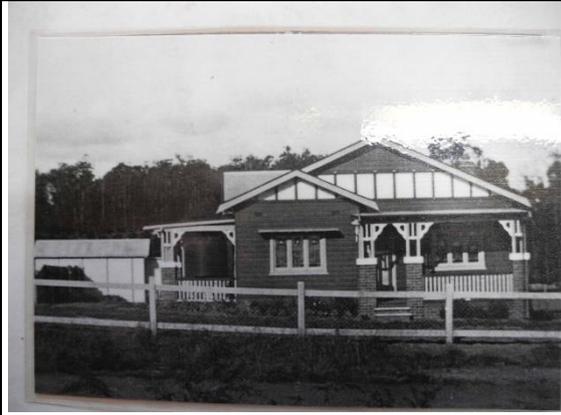
Original 1930's cottage

"A small dilapidated timber cottage (circa 1930), on the semi-rural northern outskirts of Sydney was purchased in 2012 by a young couple keen to renovate and extend. They had set their hearts on an extension consisting of an open plan family/living/dining room with a kitchen and pantry. The 4 bedrooms (2 with en suites) and a redesigned bathroom would be renovated/extended in the existing cottage.

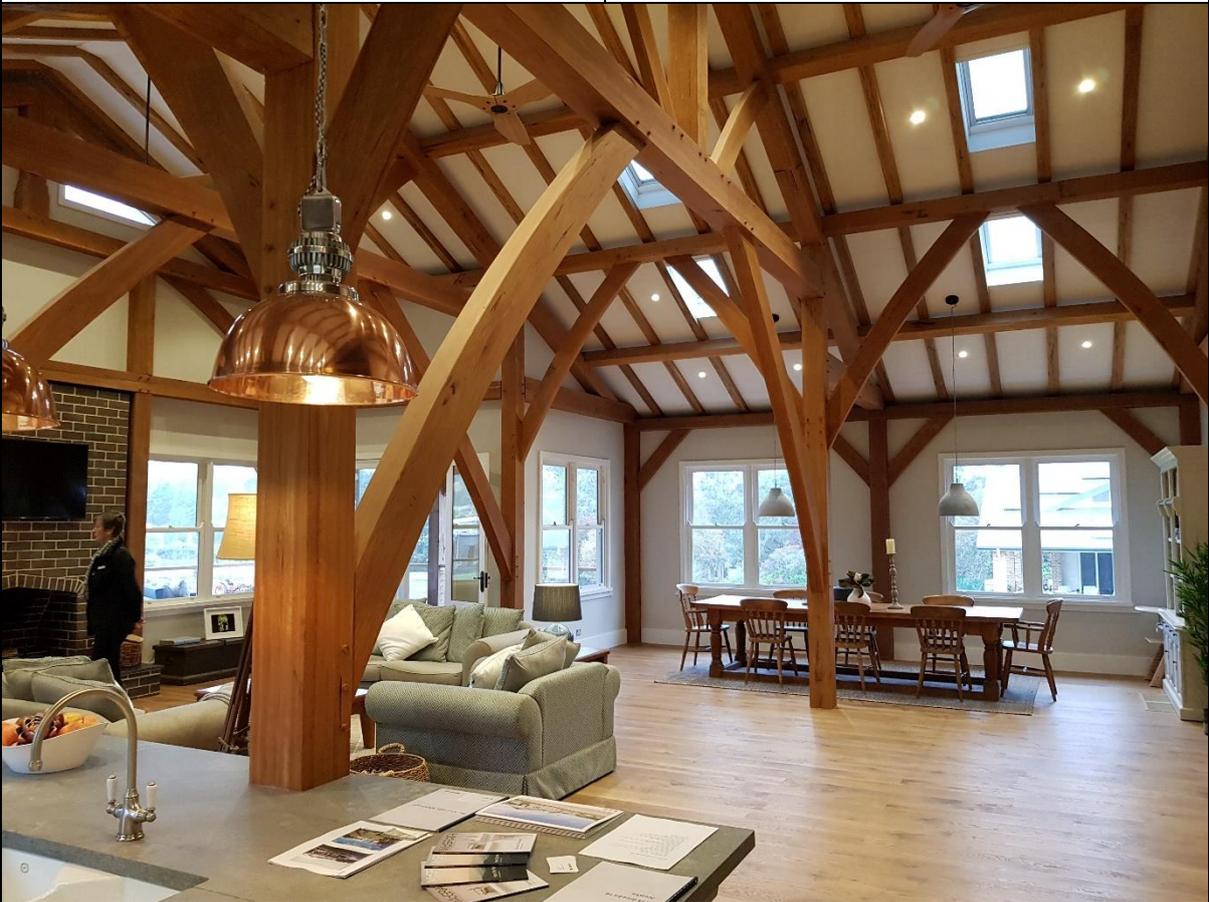
Completed Project

Chris cut and assembled the hardwood frame in his open-air workshop (a paddock with shed), then dismantled and transported it to Sydney. Within a matter of days, the numbered timber elements were erected on site and pinned with hardwood dowels. There are NO metal fixings in the structure, apart from the galvanised hold down plates.

The timber dowels, left projecting, are a signature of this method of construction. The mortise and tenon dowelled joints are crafted to allow for both longitudinal and transverse shrinkage over time, as the 200x200 posts and main rafters, 250x200 transverse beams are still mainly unseasoned on installation."

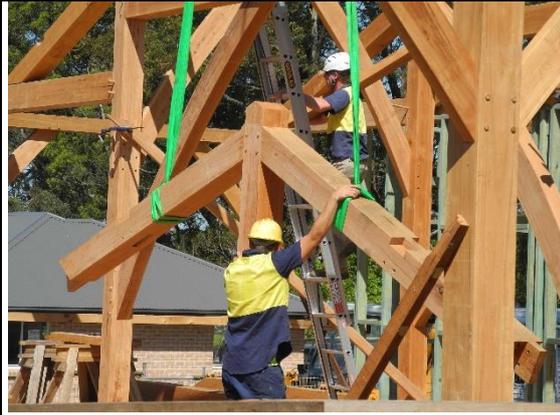
During Construction

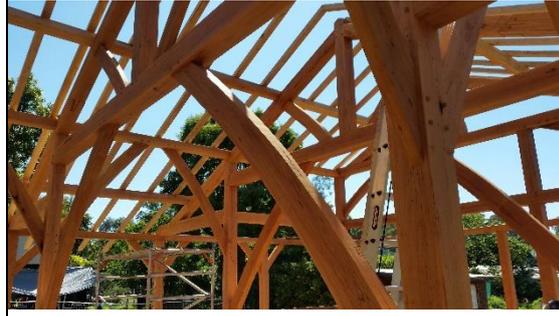
During Construction

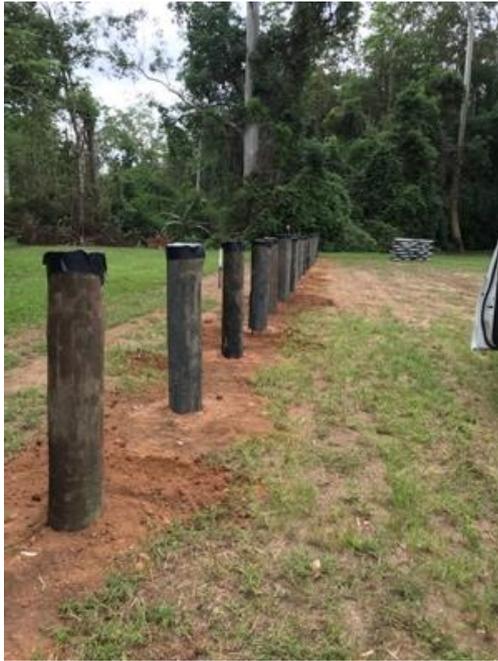
Figure 1. Poles in test at the new DAF Nambour test site

The Centre commenced September 2018 and is based out of the DAF EcoSciences Precinct in Brisbane. Although we are still in the development phase, we have initiated a number of projects. Our DAF partners have worked to establish a large-scale field trial incorporating all of the treatments currently used in Australia for H3 (above ground decking) exposures at South Johnstone (Far North Queensland) and their new site near Nambour. This trial will assess the performance of over 20 different treatments on solid pine, plywood and laminated veneer lumber and the resulting data will help inform Australians about how some of the newer treatments perform while providing data to help improve the CSIRO models.

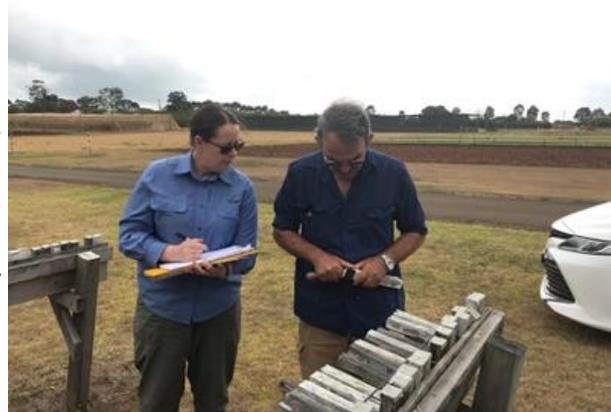
Figure 2. DAF personnel Ms. Lesley Francis and Mr. Jack Norton inspect a long term I-joint trial.

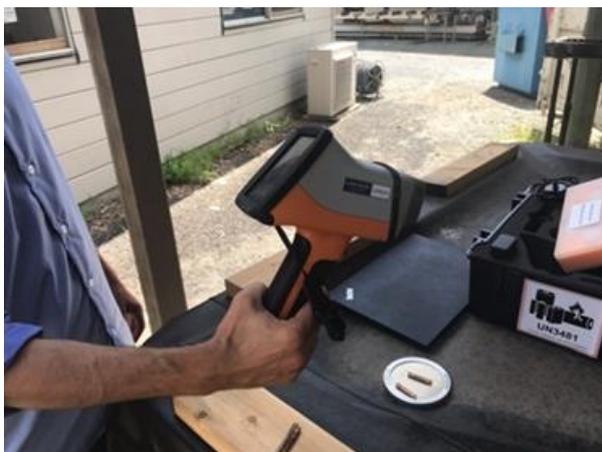
Figure 3. The handheld x-ray fluorescence unit used to evaluate quality of CCA treated timber.

We've also run some trials with a hand-held x-ray fluorescence unit for assessing preservative treatment, held one workshop on utility pole maintenance and a workshop on statistical process control, but we are always looking for better ways to reach out.
